Overcoming Challenges in the Bored Tunnel Construction under Beiheng Expressway Package II

By Dr. Xiao Xiaochun

The Hong Kong Institution of Engineers

Date : 21-08-2019

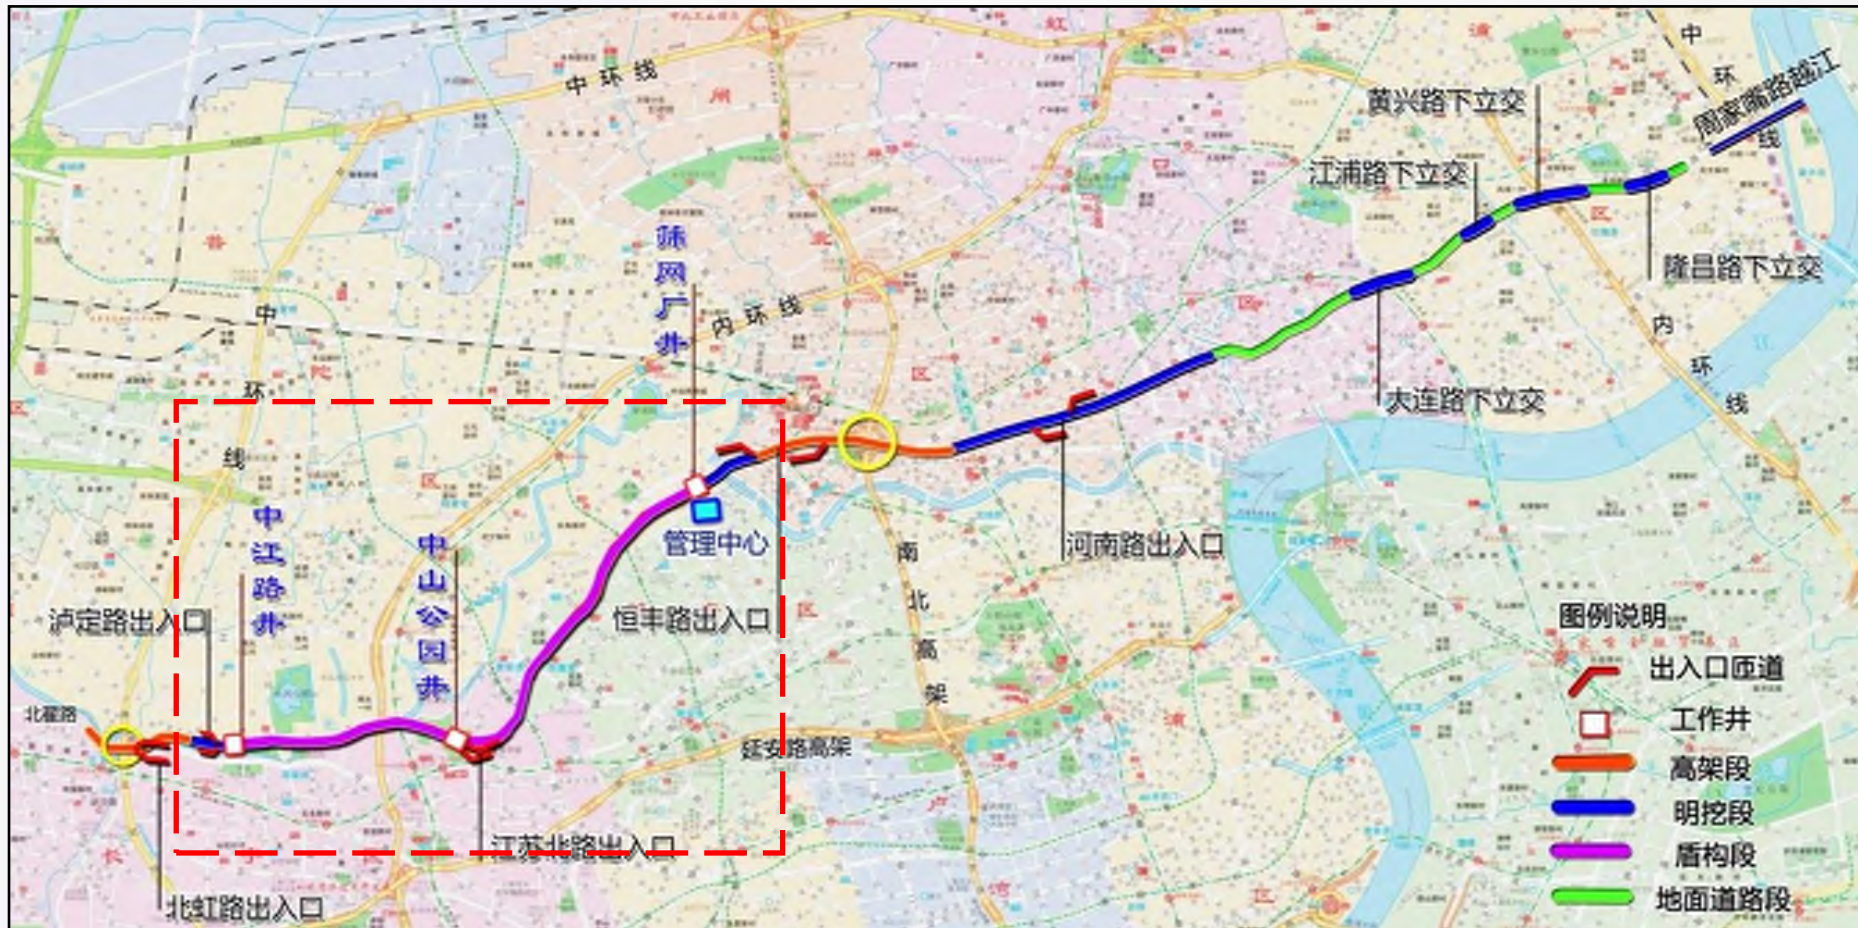
BEP starts from the west of Middle Ring Beihong flyover and ends at Neijiang Road (East). It is 19.1km long and runs through the north area of Shanghai Urban Center.

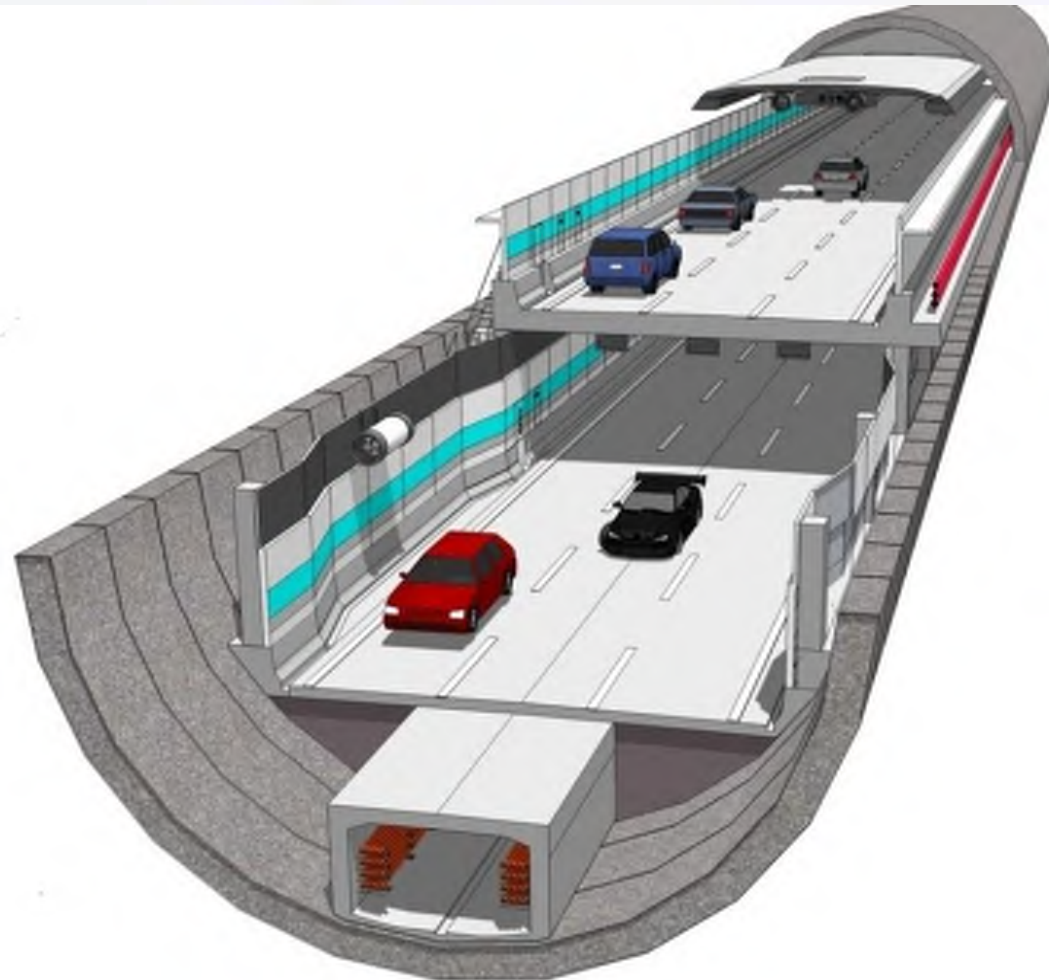
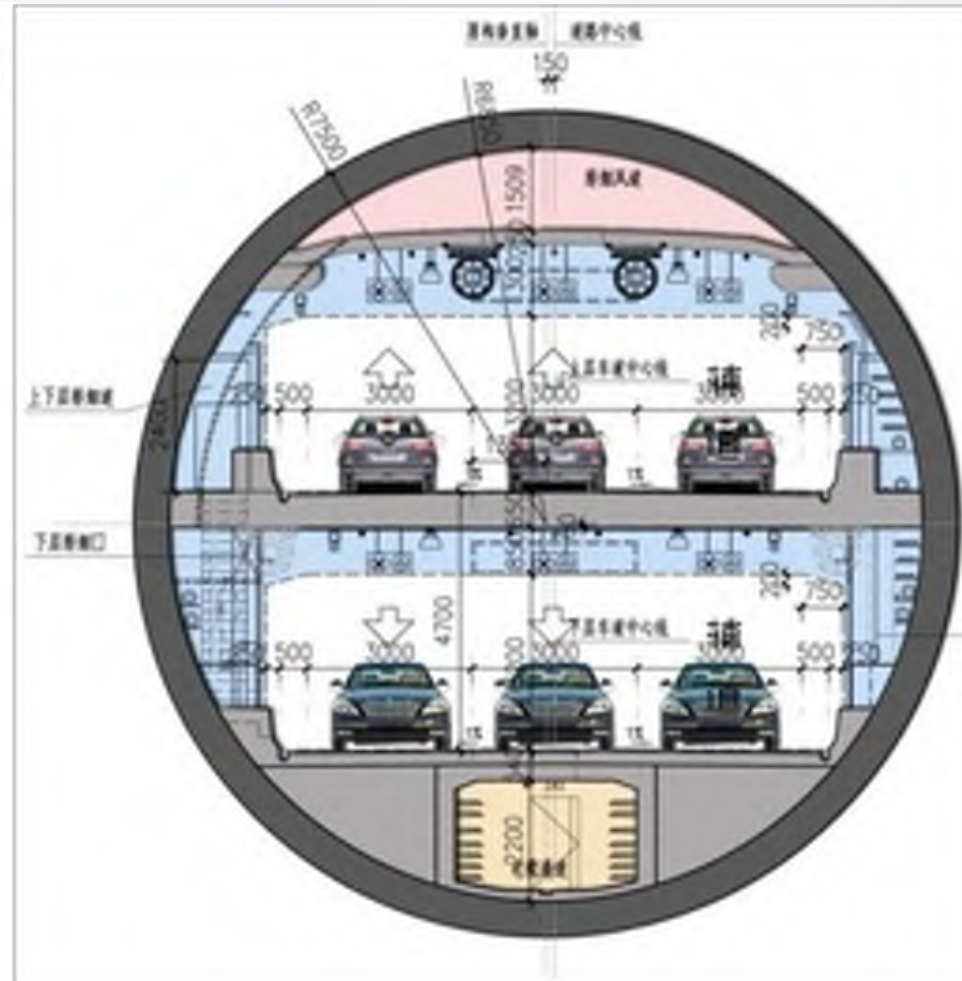
Segment Lining Design

OD: 15000mm	ID: 13700mm	Width: 2000mm	Grade: C60 with waterproofing Grade P12
Segment Configuration:		9 + 1 (7 standard p (B1 – B7), 2 adjoining (L1, L2), & 1 Key (F))

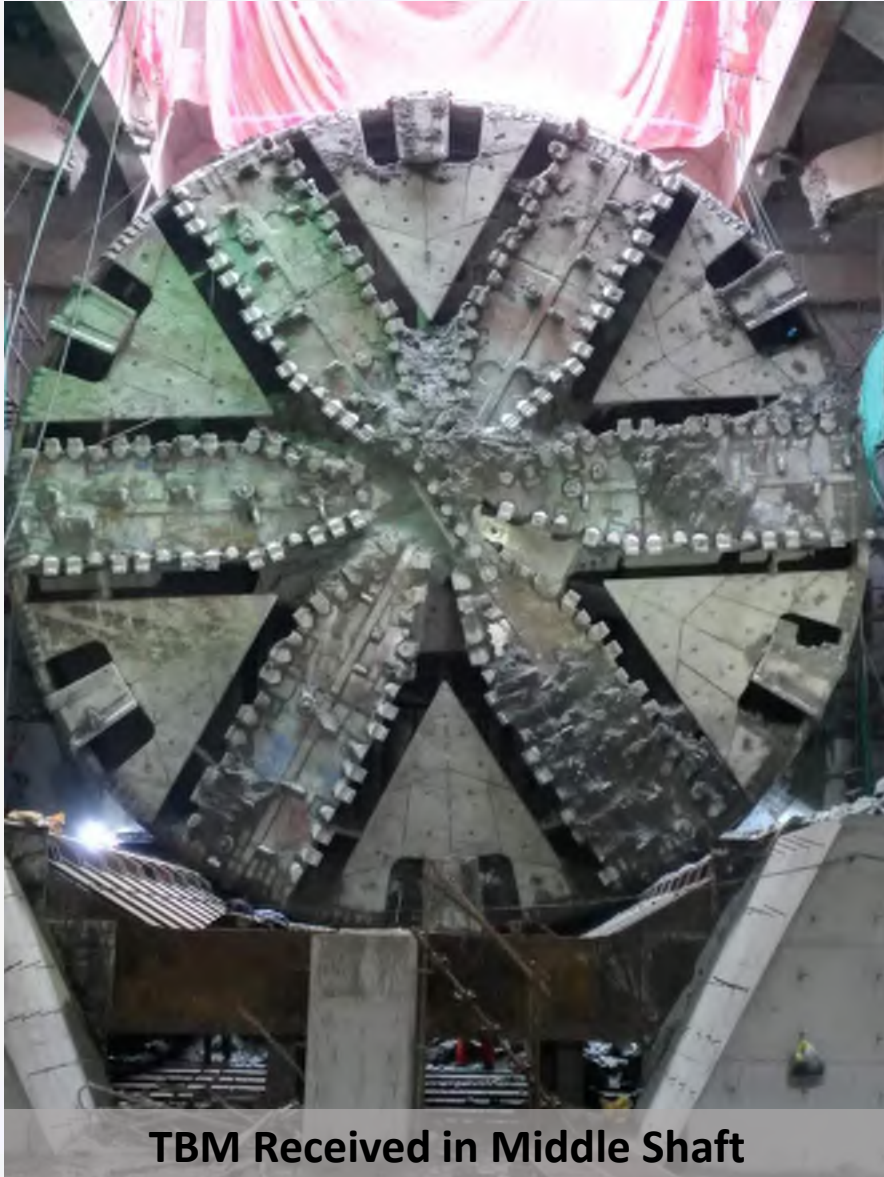
TBM Received in Middle Shaft

TBM was launched on 26th Dec 2016. Break-out into the middle shaft on end-2017, signaling the completion of the 1st drive.

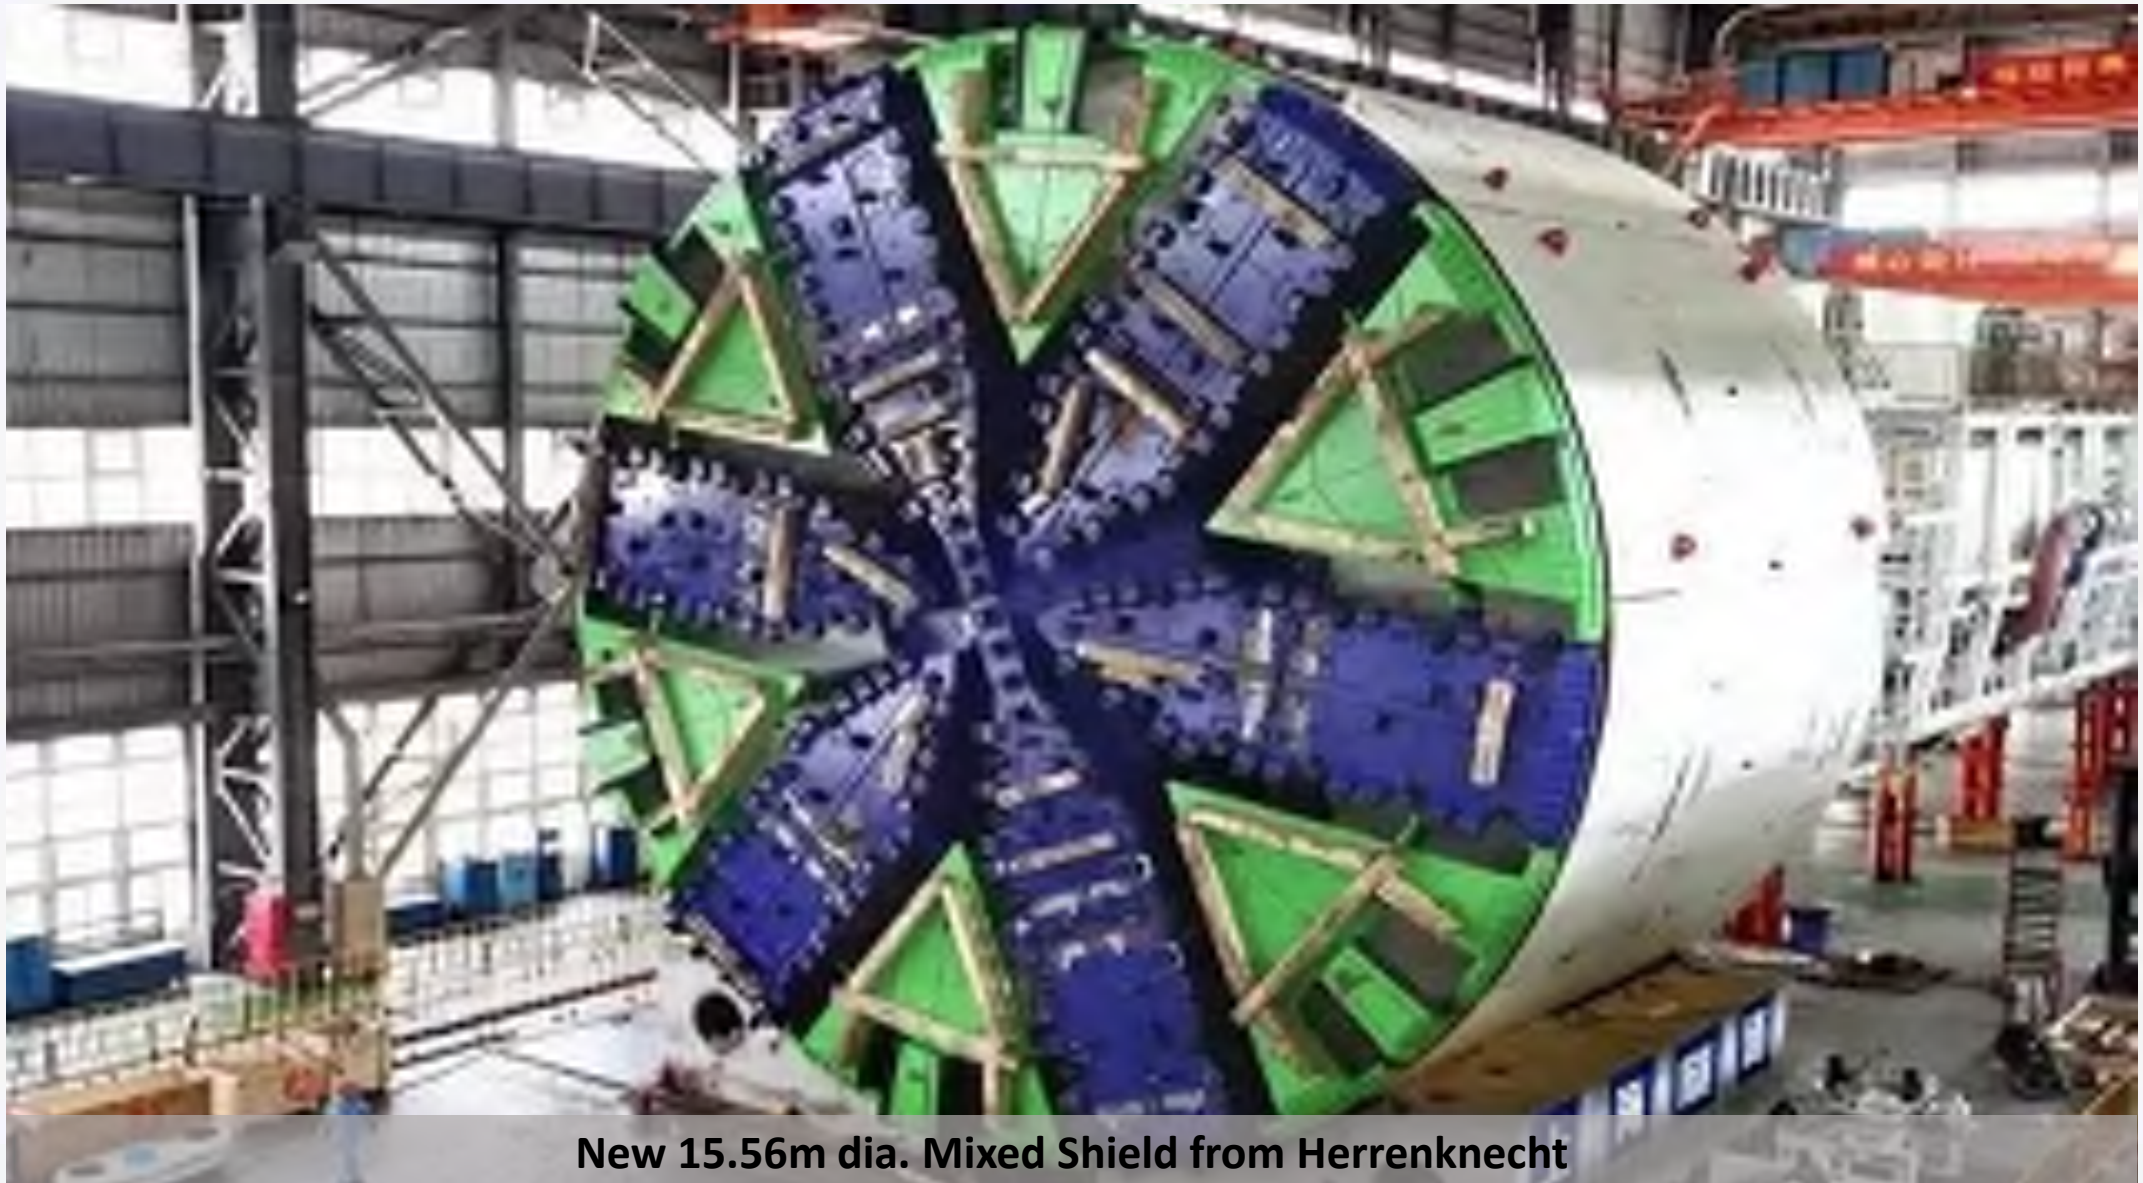
New 15.56m dia. Mixed Shield from Herrenknecht

Item	Description
TBM Type	Slurry Pressure Balance TBM with air cushion chamber
Cutter Head Diameter	15560mm
TBM Shield Structure	Central Body + 10-piece blocks
Total Thrust Force	200,000 kN
Working Pressure	8 bar
Thrust Cylinders	19 groups (3 cylinders per group) (360 / 280 – stroke 3m)
Main Drive	DN7600, 13 nos. variable frequency electrical motors

Item	Description
Segment Erector	Middle support type, vacuum gripper
Backfill Grouting	8 x 2 points (DN65, 1 duty, one spare)
Tail Seal Grease	3 x 19, DN25
Tail Seal Brush	3 rows of steel wire brushes + 1 row spring plate
Man Lock	Ø2000mm, 6 persons + 2 persons
Material Lock	1 no.

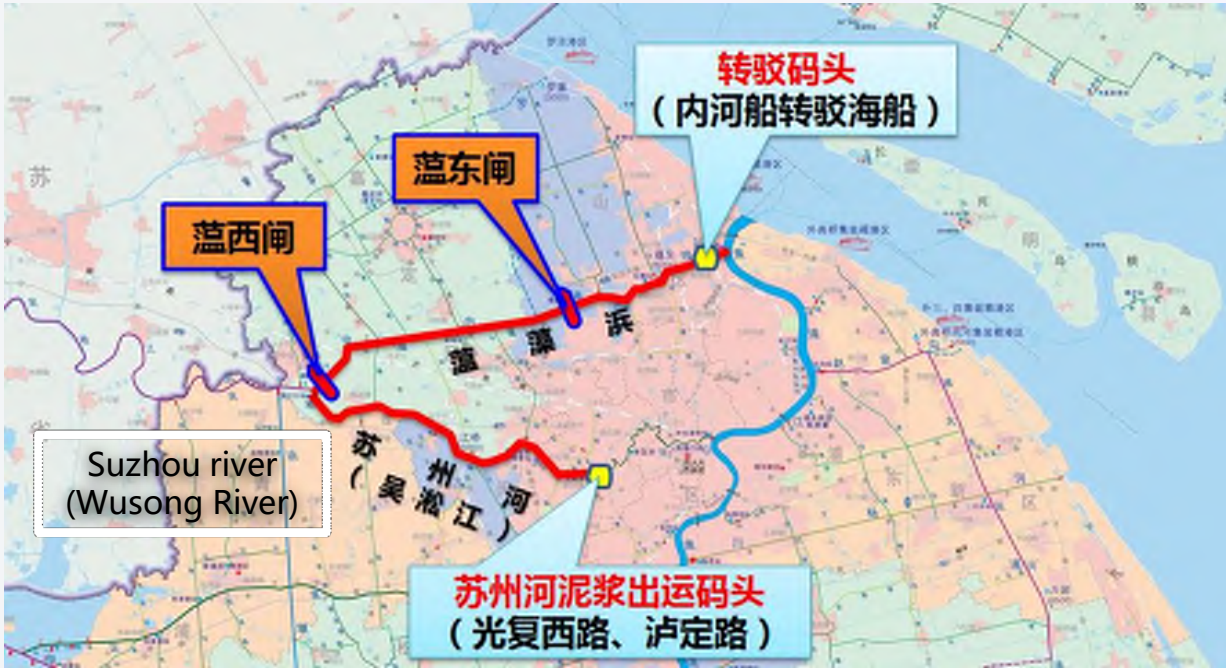
River Boat Transit Route :

Slurry shipment pier \leftrightarrow Suzhou Canal \leftrightarrow Yunzao Canal (Yunxi Gate and Yundong Gate) \leftrightarrow **Transfer port**. Distance is around 60km.

Ship Transit Route :

Transfer port \leftrightarrow Yunzao river \leftrightarrow Huangpu River \leftrightarrow Wusong Security Guard \leftrightarrow South Port \leftrightarrow Yuansha Security Guard \leftrightarrow North Channel \leftrightarrow hydraulic fill reclamation Area。 Distance is around 73km.

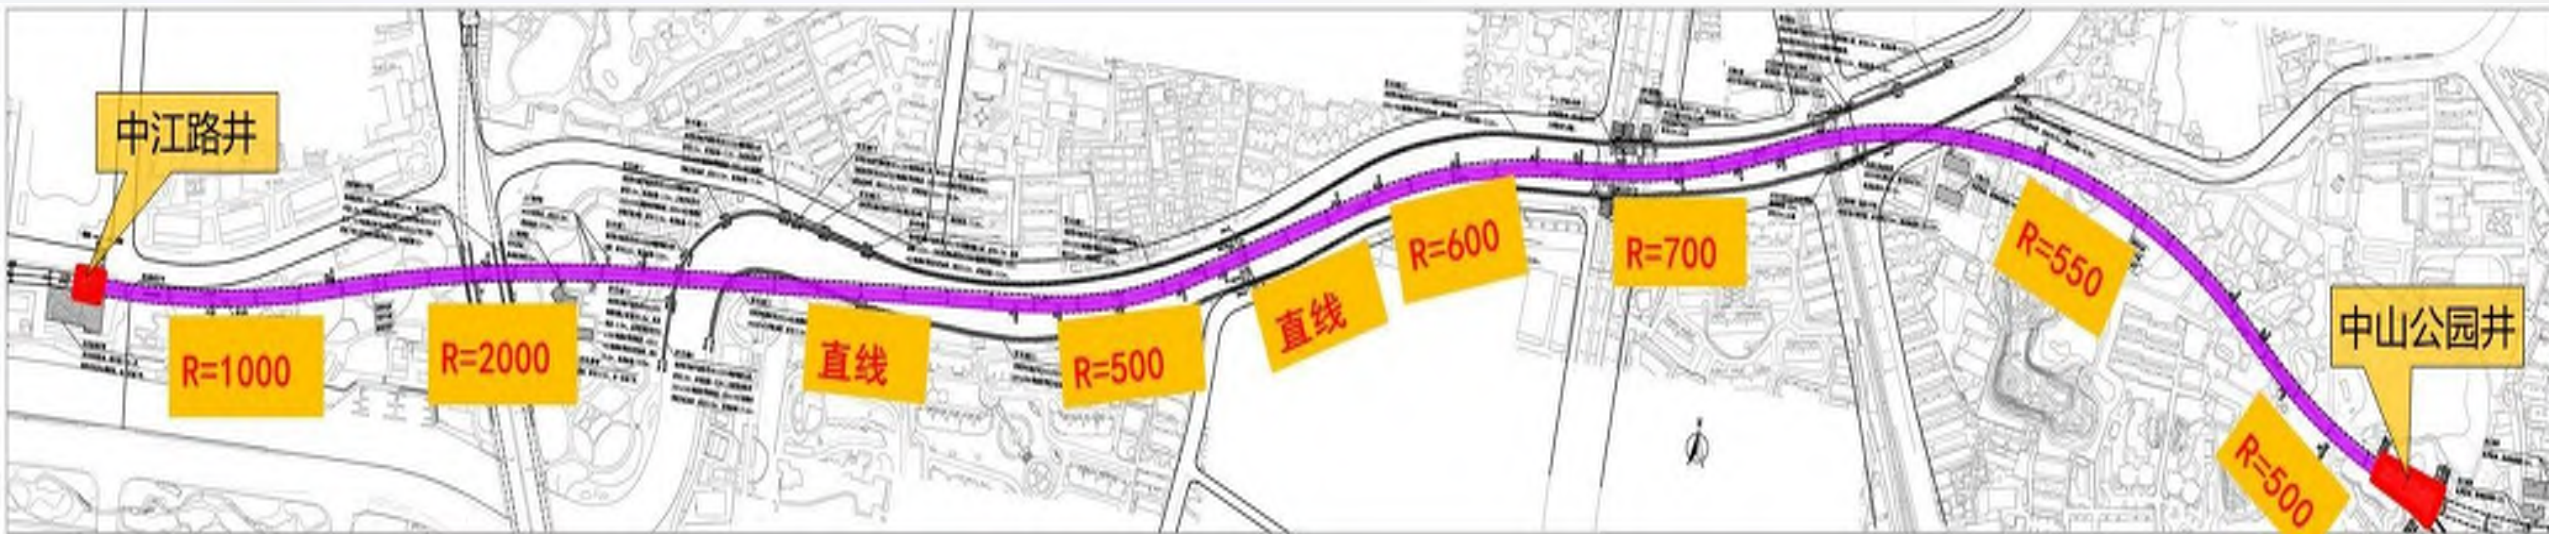
TBM First Drive (Total: 2761m, Tight curve sections: 1016m)

Radius of curves (m)	500	550	600	700	1000	2000	Transition	Straight
Percentage (%)	12.4	18.0	6.4	4.7	9.5	12.7	15.9	20.4

36.8%

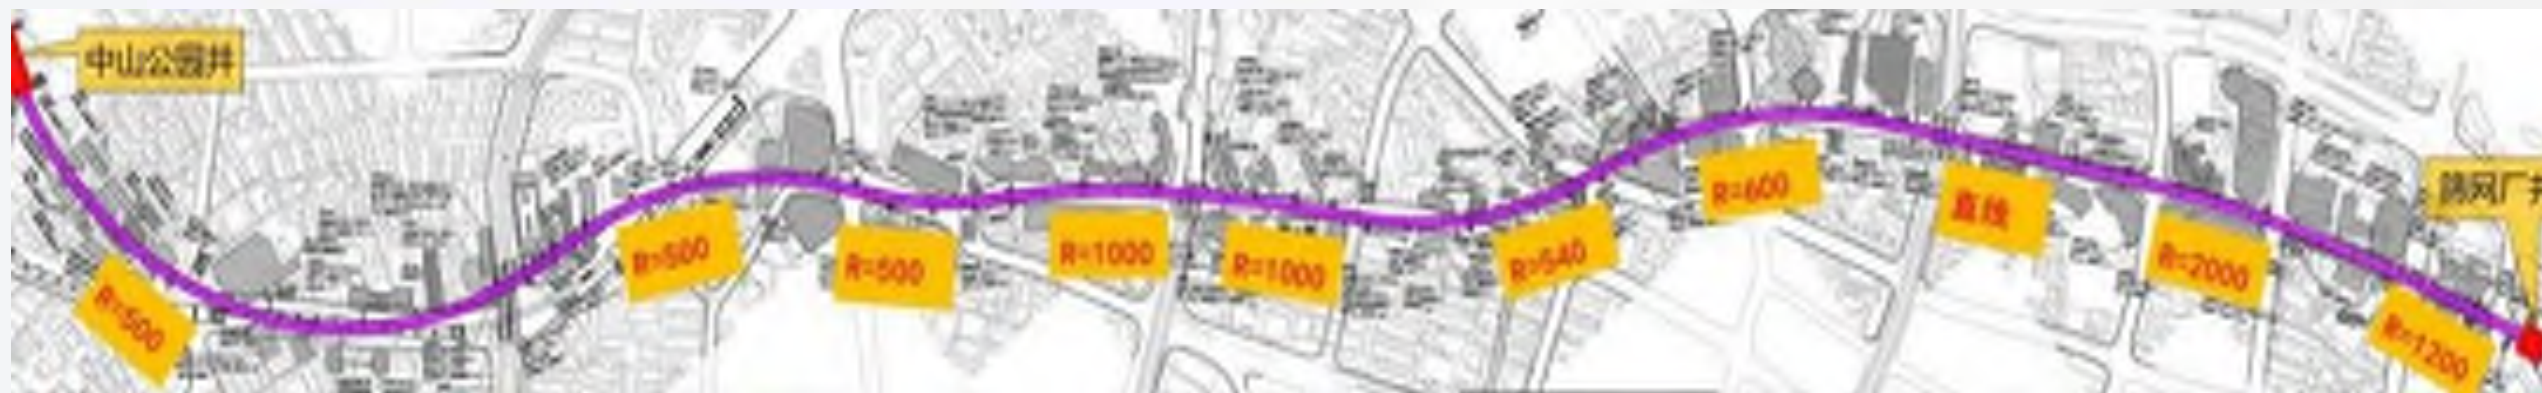
TBM Second Drive (Total: 3664m, Tight curve sections: 1872m)

Radius of curves (m)	500	550	600	700	1000	2000	Transition	Straight
Percentage (%)	34.3	7.7	9.1	0.5	8.4	10.7	13.7	15.5

51.1%

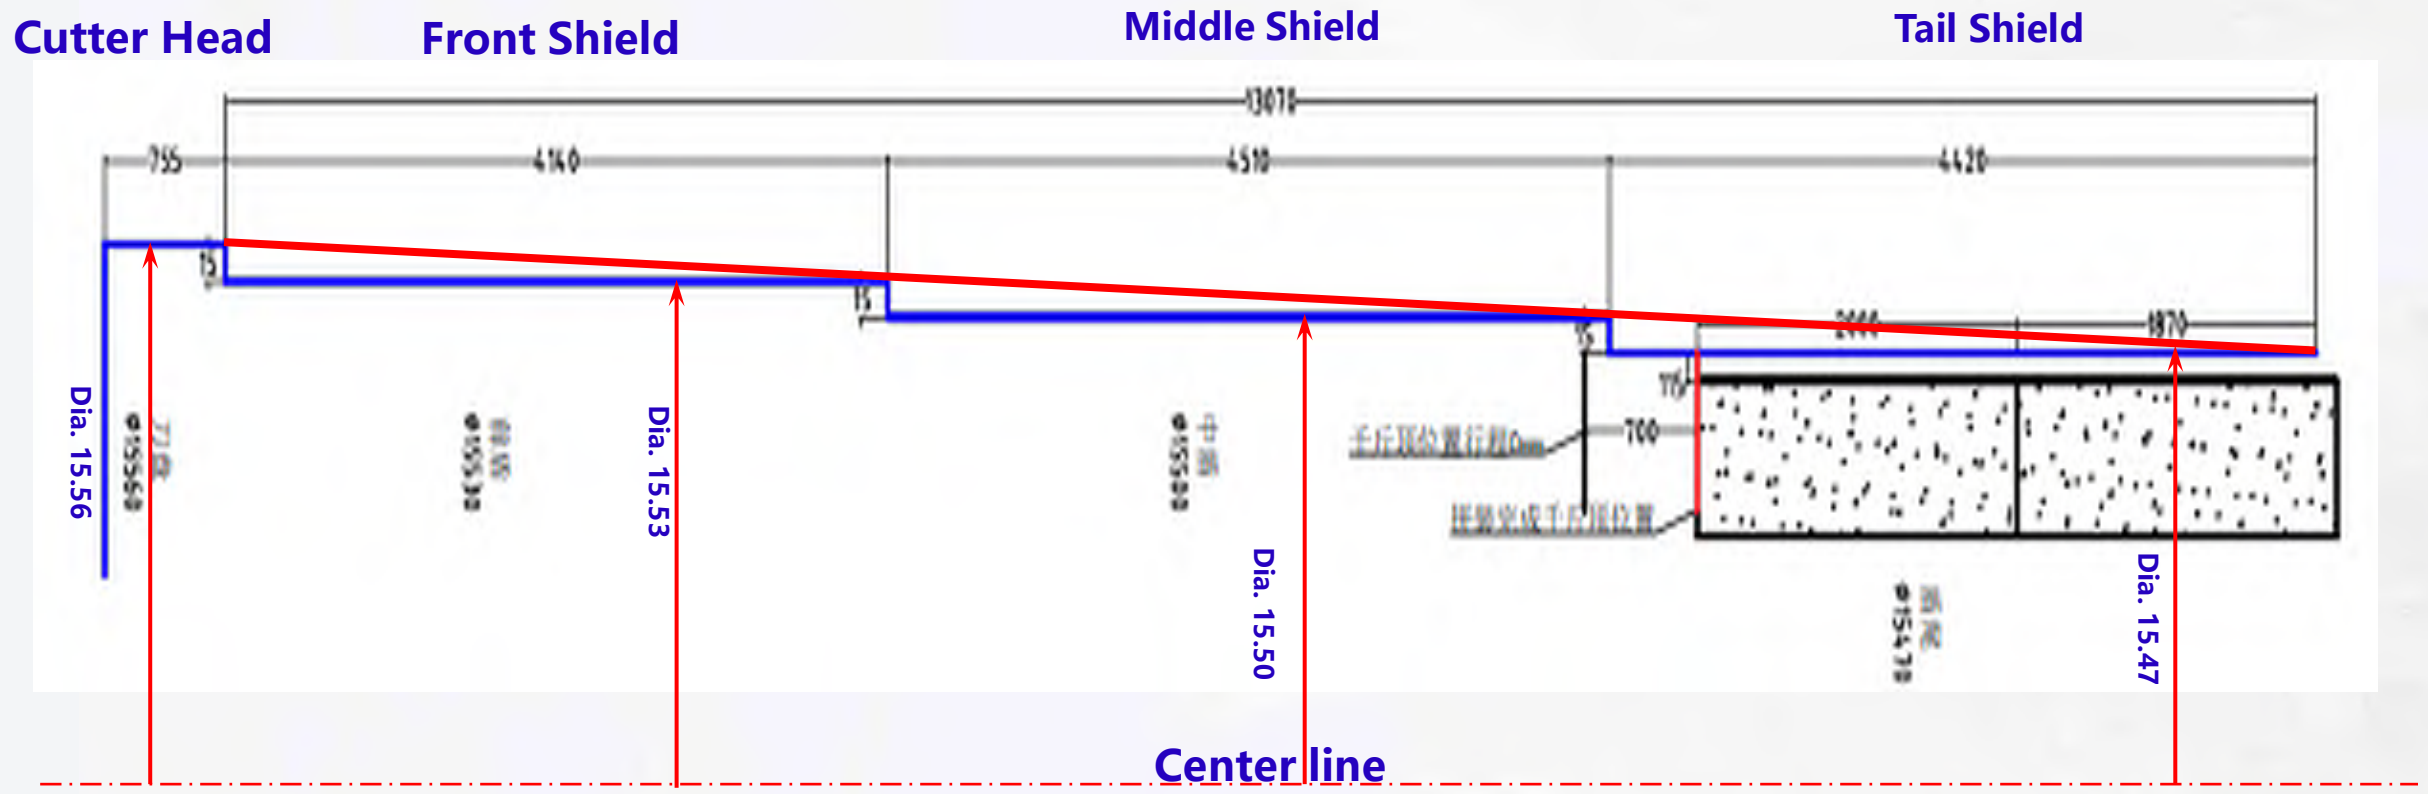
Tapered Shield Design

Solutions – Special TBM Design (Tapered Shield)

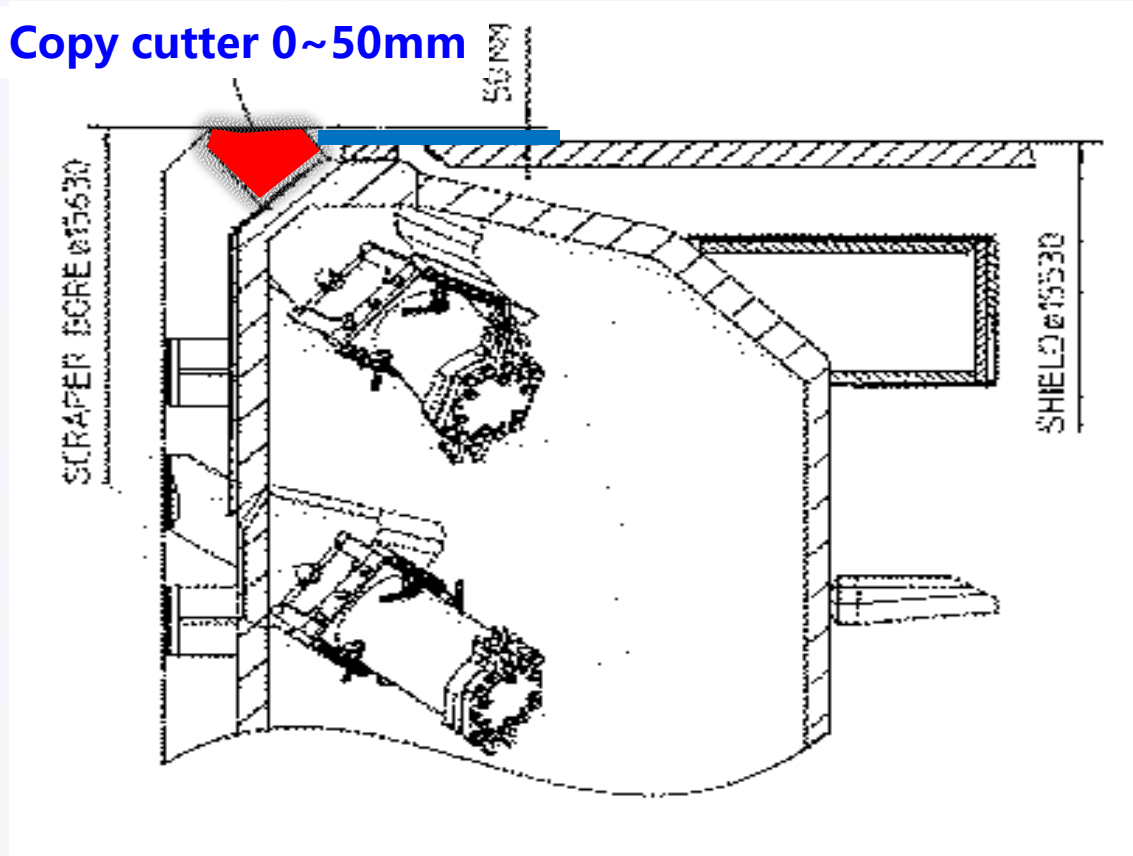
Copy cutter 0~50mm

Radius of curve (m)	Extension (mm)
300	50
500	30
800	15
1000	0

4 nos. of copy cutters are equipped for overcut in tight curves. The amount of copy cutter extension was calculated based on curvature of the alignment.

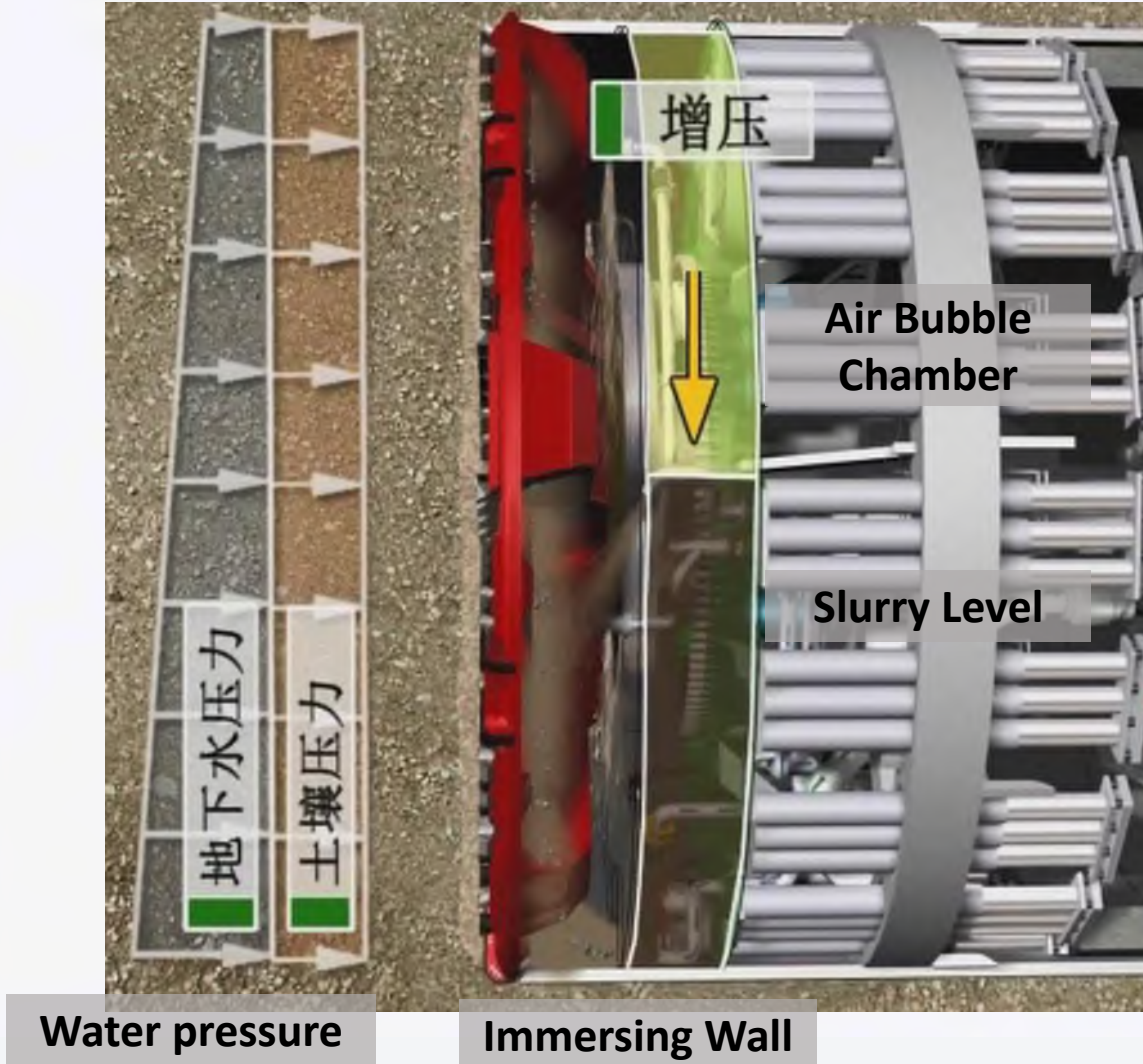
- Slurry-air balance TBM
- Maximum 8 bar working pressure allowed
- Fluctuation of air pressure is controlled within 0.5 bar
- Maintain stability of excavation surface with high precision
- Greatly avoid the disturbance caused by pressure fluctuation

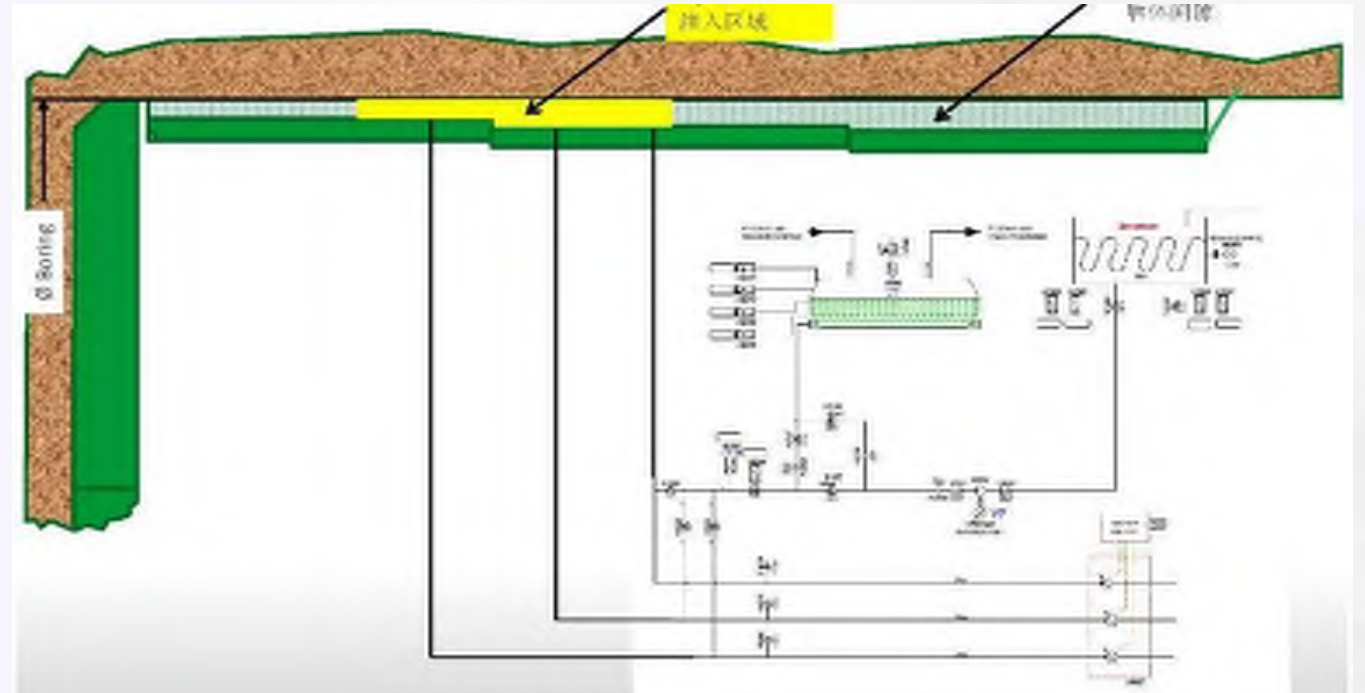
Synchronous Grouting (10 Points)

Shield Injection

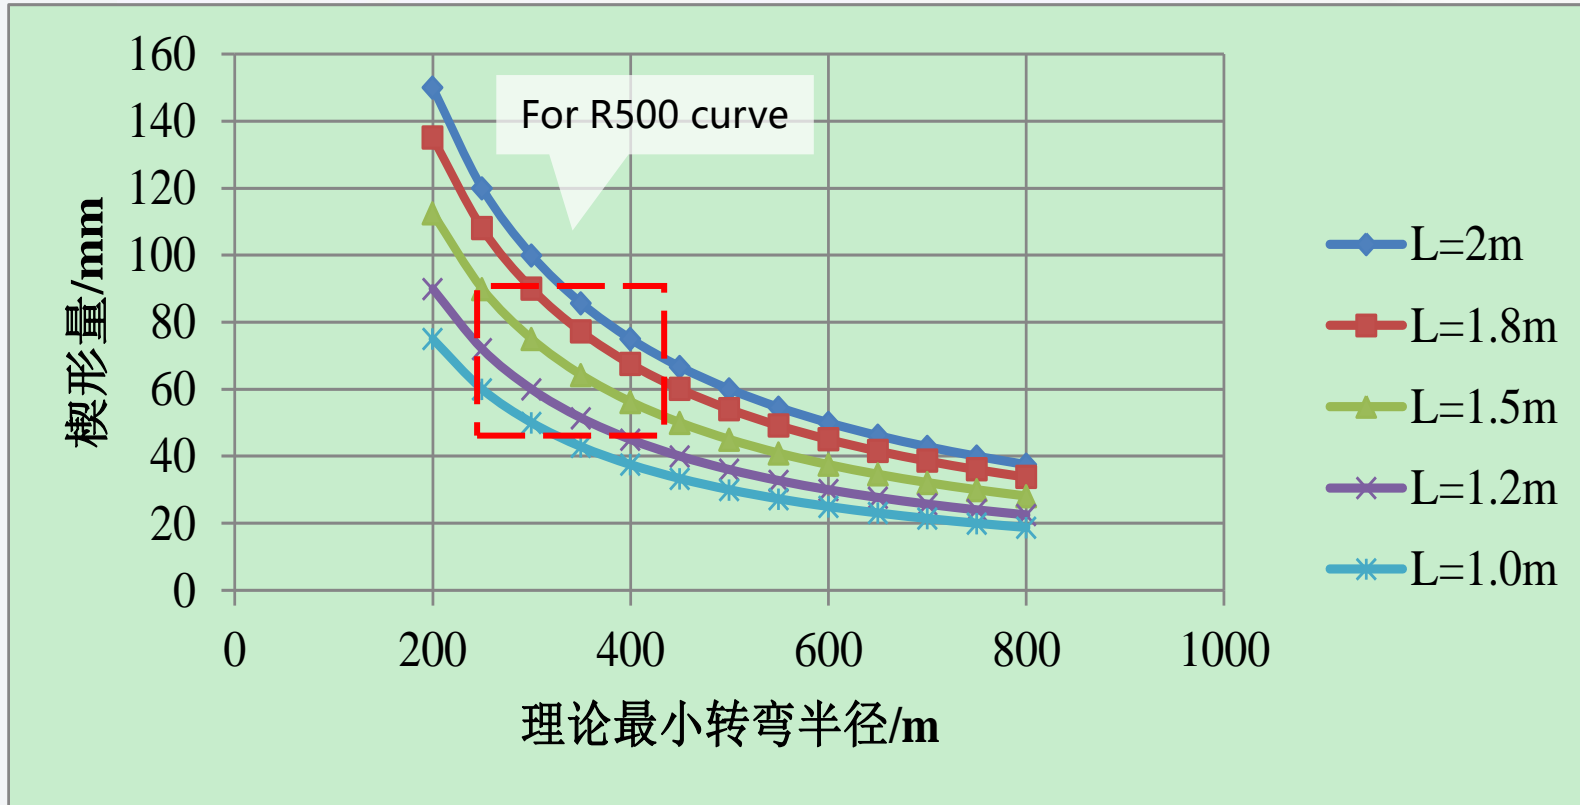
Solutions – Lining Design (Geometry)

- Previous projects in Shanghai of 15m Dia. tunnels, segment taper was designed as 40mm, and corresponding horizontal curve was 750m.
- To fit tight curve with radius of 500m, either *increase the taper or reduce the width of the segment.*

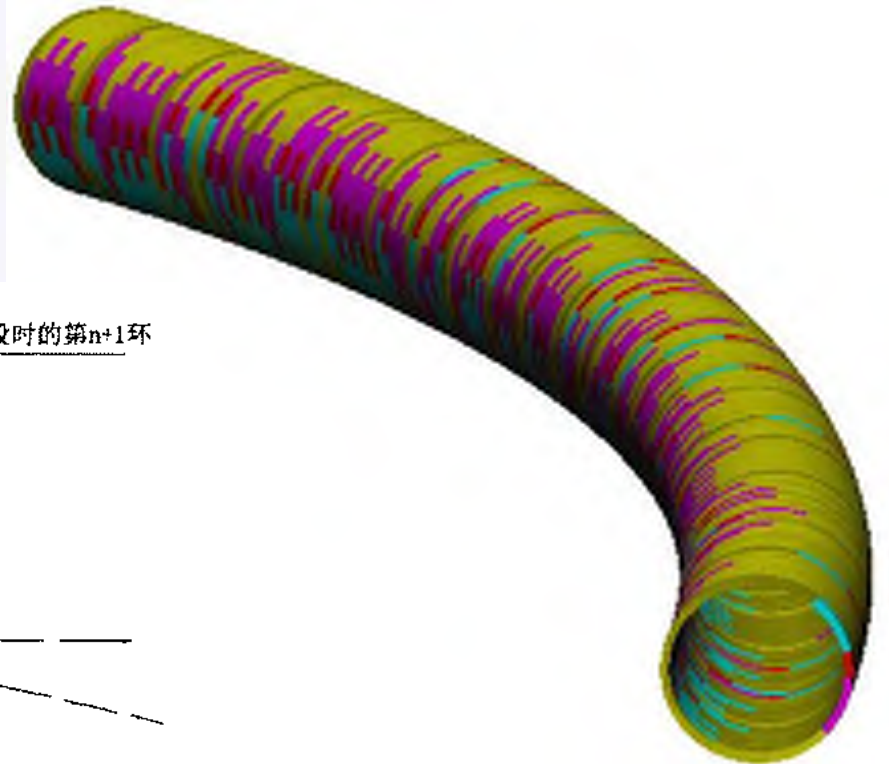
3-D Simulation

- 3-D simulation (taper=80mm width=2.0m)
- Consider worst case condition from both horizontal and vertical curve. (Horizontal curve radius=500m Vertical curve radius=2000m)
- Deviation is less than 20mm for both plane curve and vertical curve

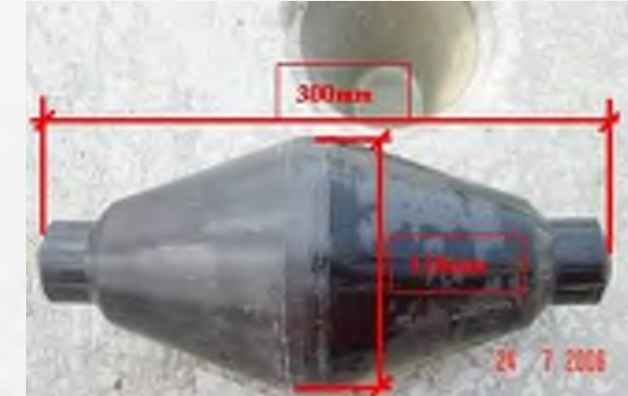
Shear Keys

For the curve section, shear keys are introduced at ring connection to increase built rings stability and integrity .

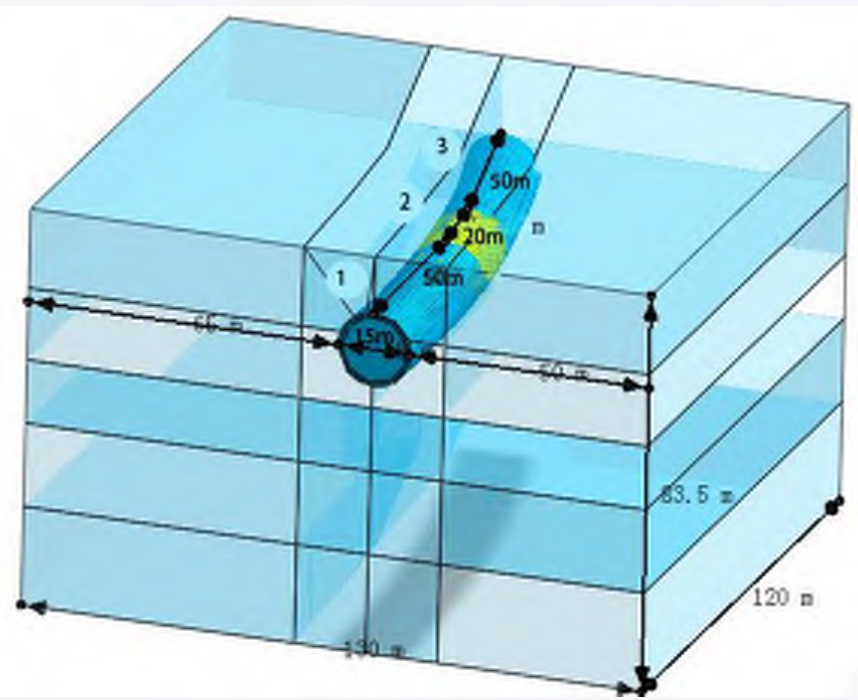
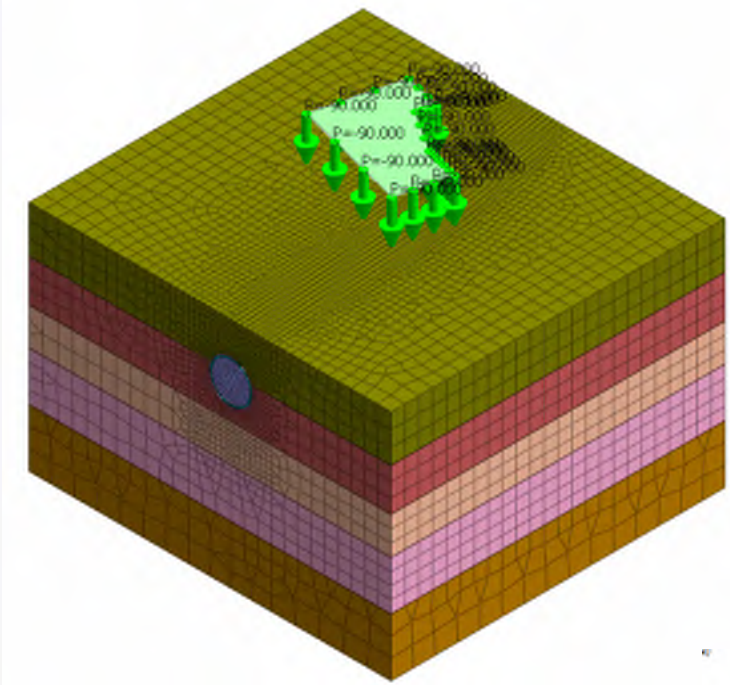
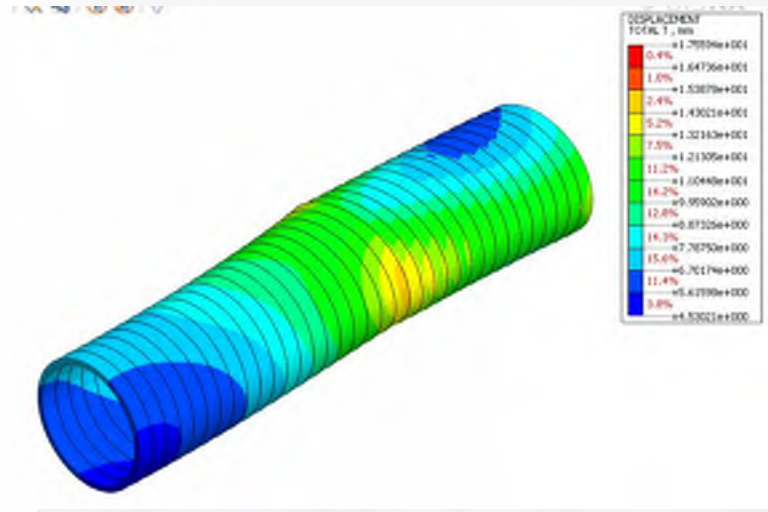
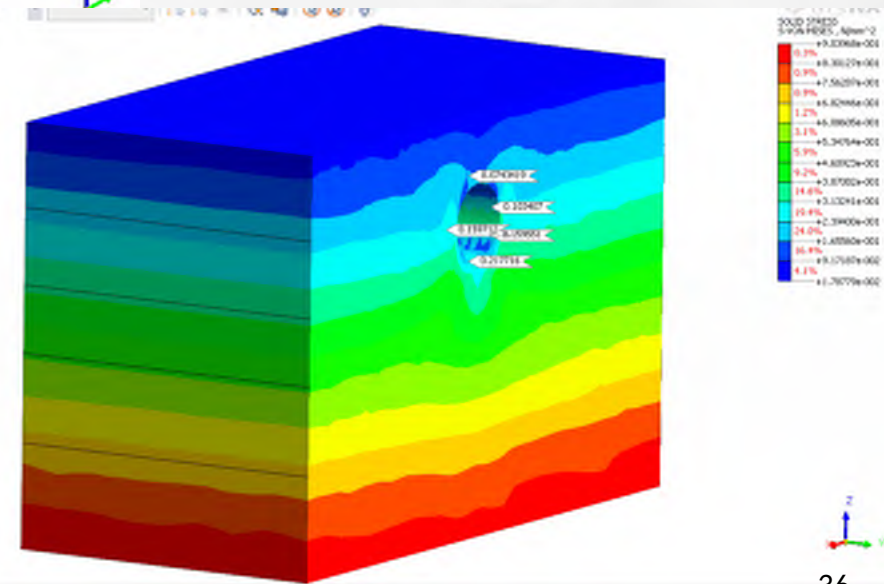
To verify the overall stability and soil stress condition during curve tunnelling, a R500 curve section beneath a 5-floor office building was selected and simulated with 3D FEM. Results revealed that the max. tunnel axis deviation is 6.4mm, no sheared failure occurred in the soil around.

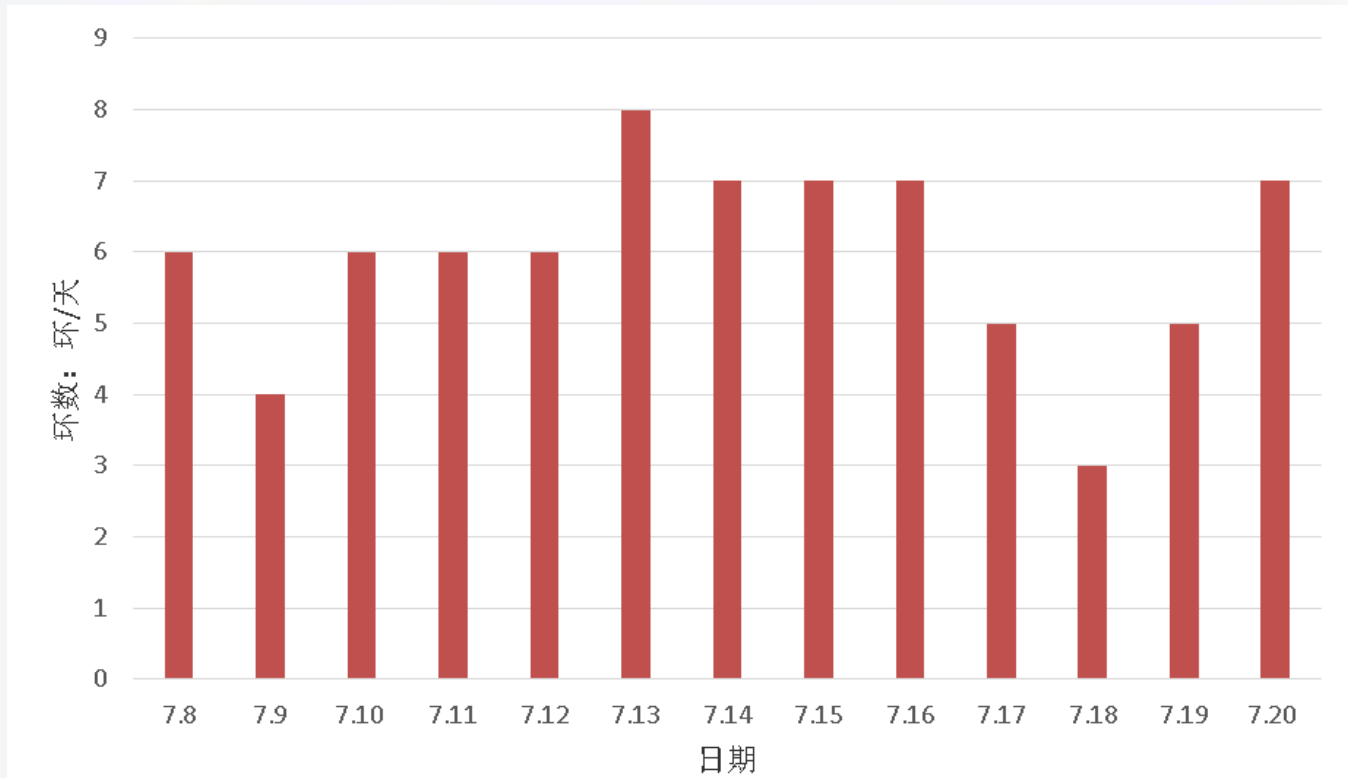
Production Rate

Efficiency Analysis
