Overcoming Challenges in the Bored Tunnel Construction under Beiheng Expressway Package II

By Dr. Xiao Xiaochun

The Hong Kong Institution of Engineers

Date : 21-08-2019

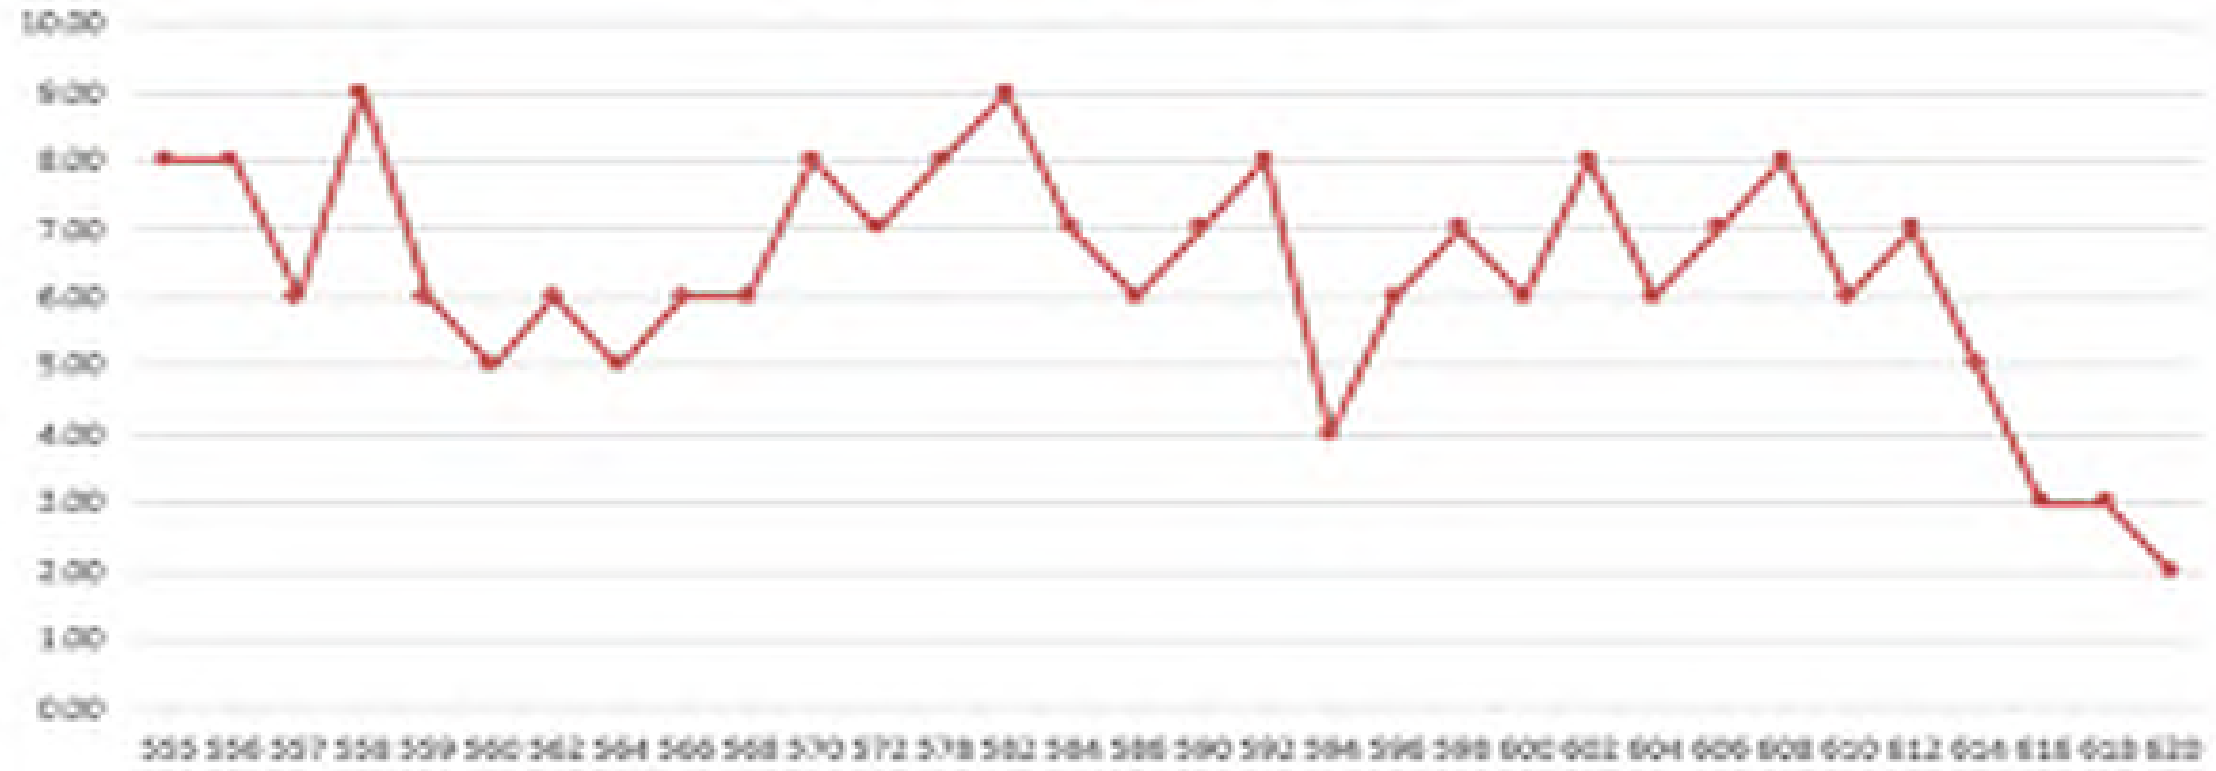
急曲线段水平位移曲线

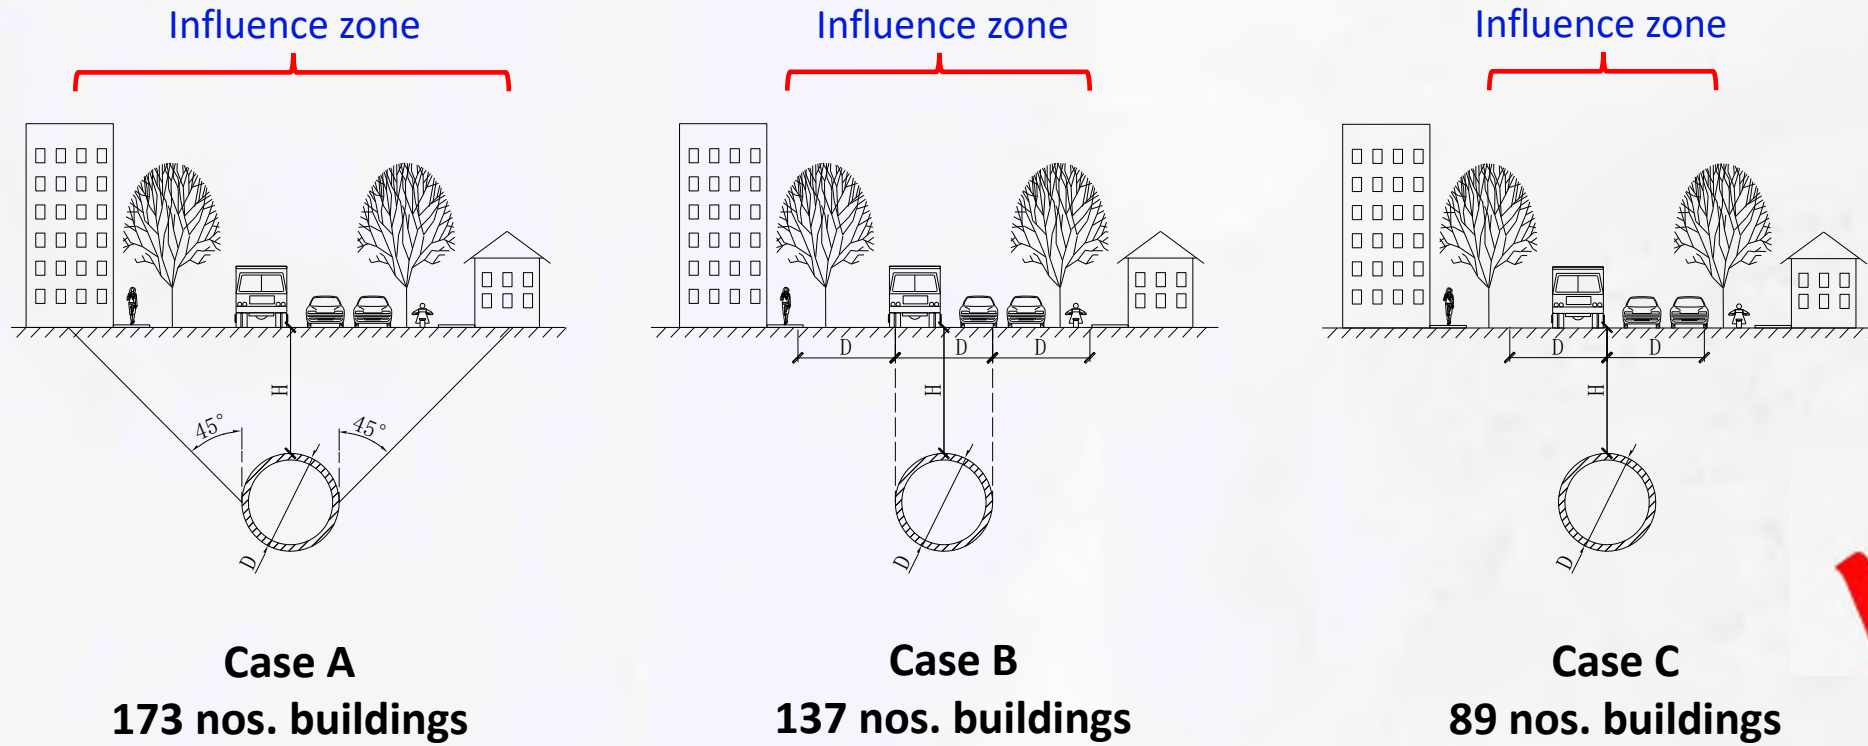
Influence Zone

For the influence zone, no regulations for the 15m diam. TBM was specified, the 3 cases were studied and reviewed and previous experiences were referred as well, and Case C was selected as the influence zone this project.

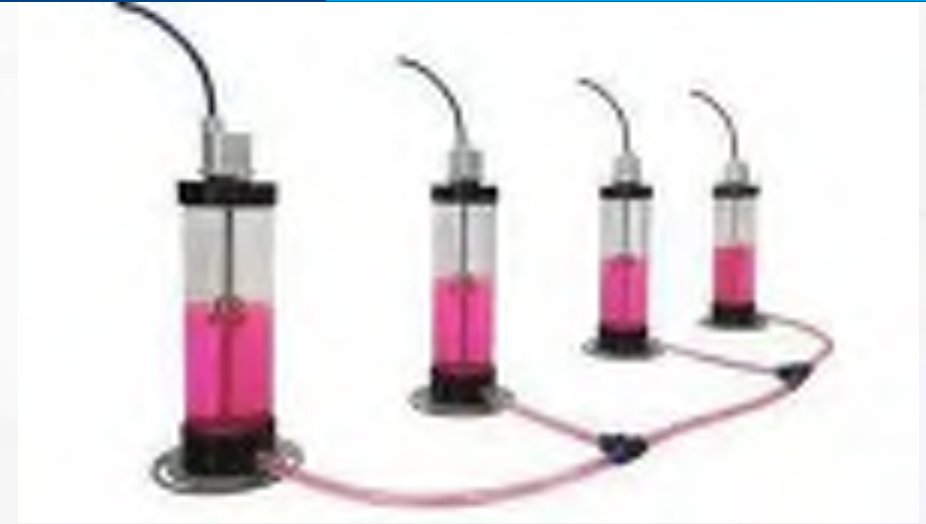
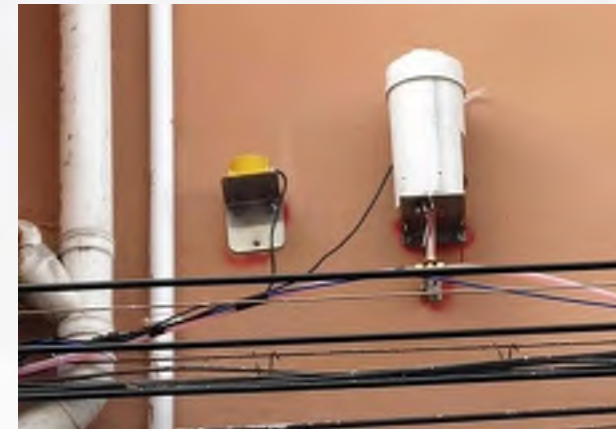
Hydrostatic Leveling System

In case of high risks including 14 buildings, the automated monitor — Hydrostatic Leveling system were used.

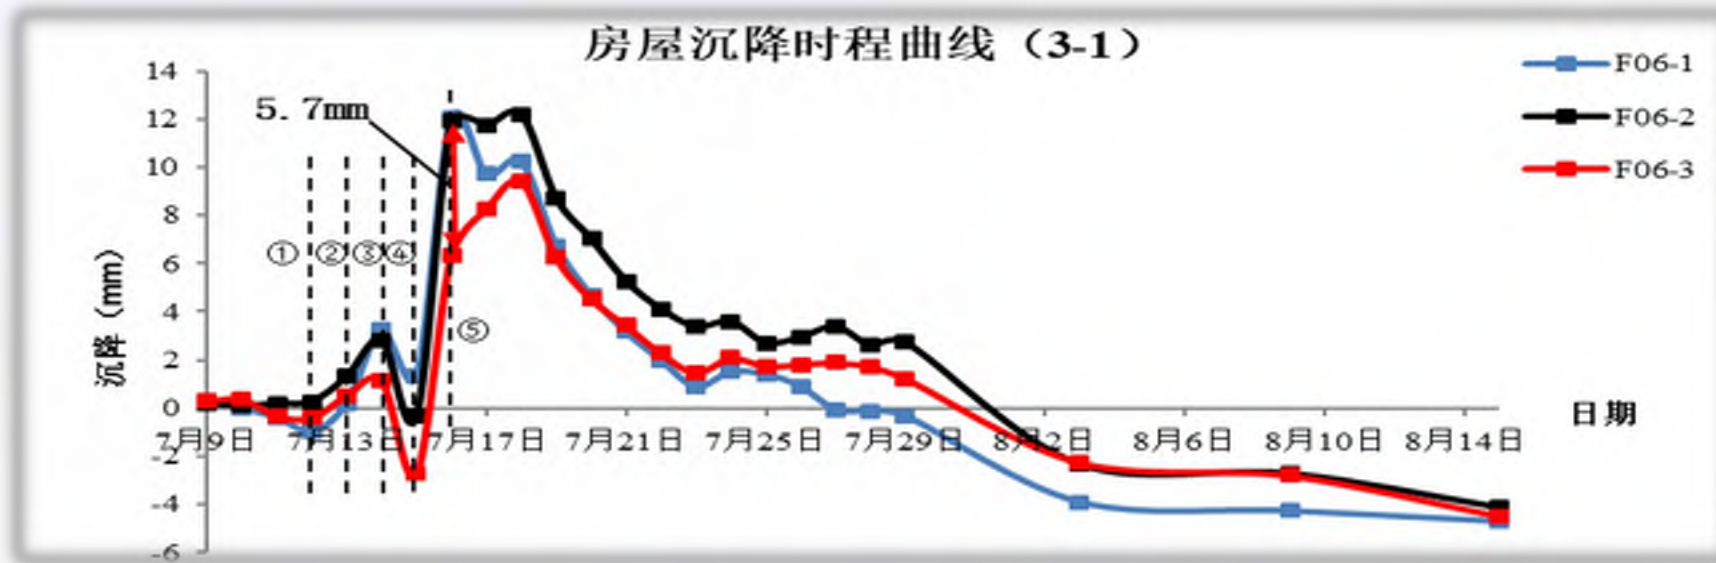
Tunnelling under the Zhaofeng Villa (3-1) :

- The overburden is 14.8m, less than the TBM diameter;
- Horizontal curve R500, Gradient = 3.8% downhill;
- Maximum heaving: +12mm, maximum settlement -4mm, maximum differential settlement 5.7mm

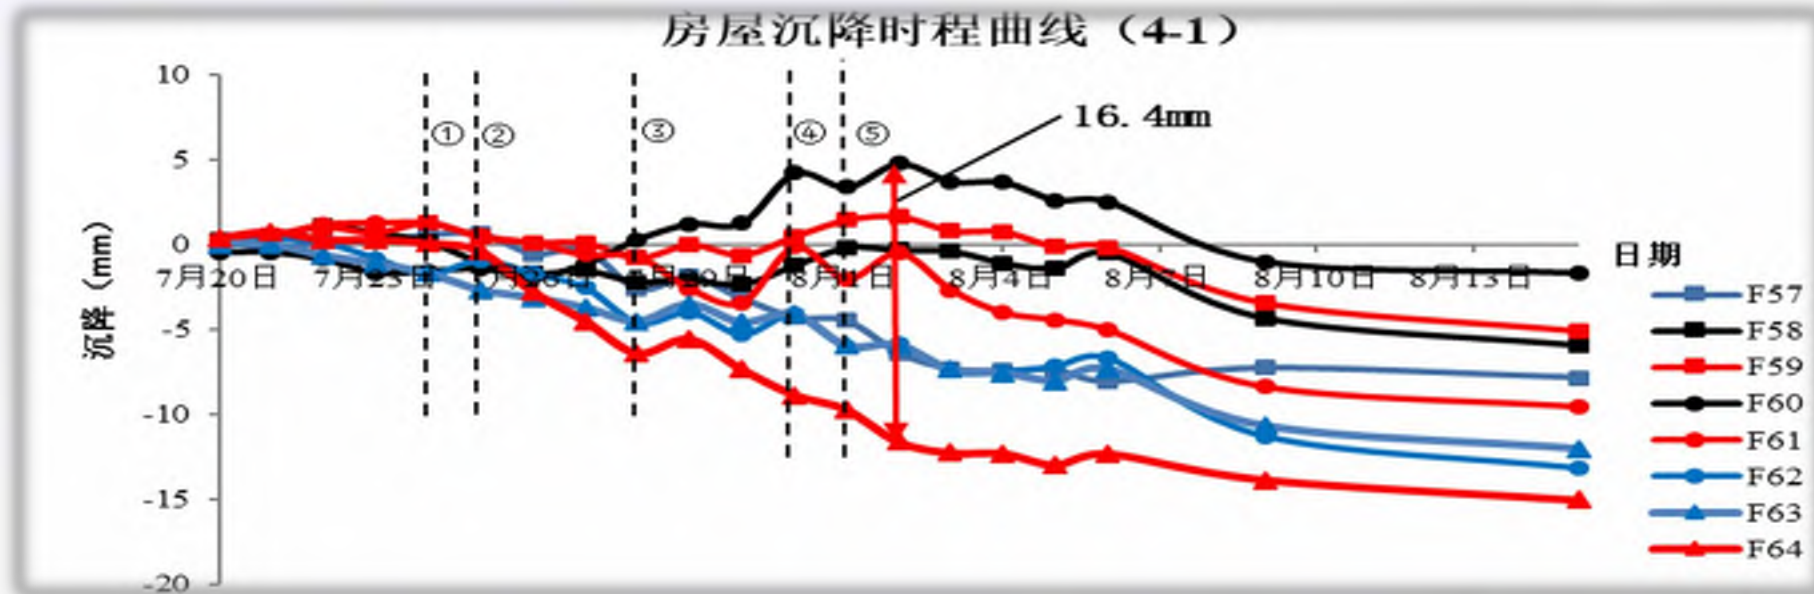
Tunnelling under the Xunfa Apartment (4-1) :

- Overburden is 21~22m, more than the TBM diameter;
- Horizontal Curve R=500, Gradient =3.8% downhill;
- Maximum heaving: +5mm, maximum settlement -15mm, maximum differential settlement 16.4mm

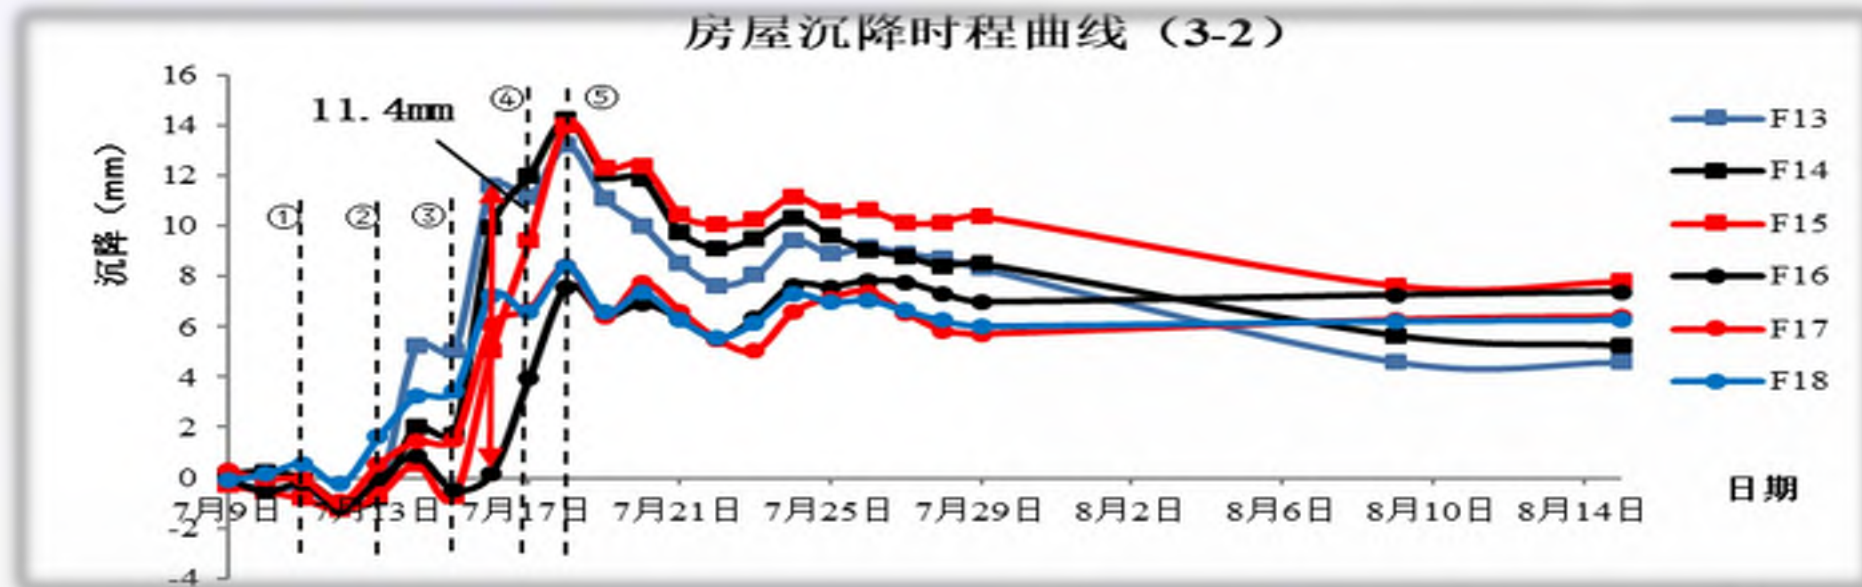
Tunnelling beside Zhaofeng Villa (3-2):

- Overburden is 15~16m
- Horizontal curve $R=500$, Gradient = 3.8% downhill;
- Maximum heaving: +13mm, maximum settlement -1mm, maximum differential settlement 11.4mm

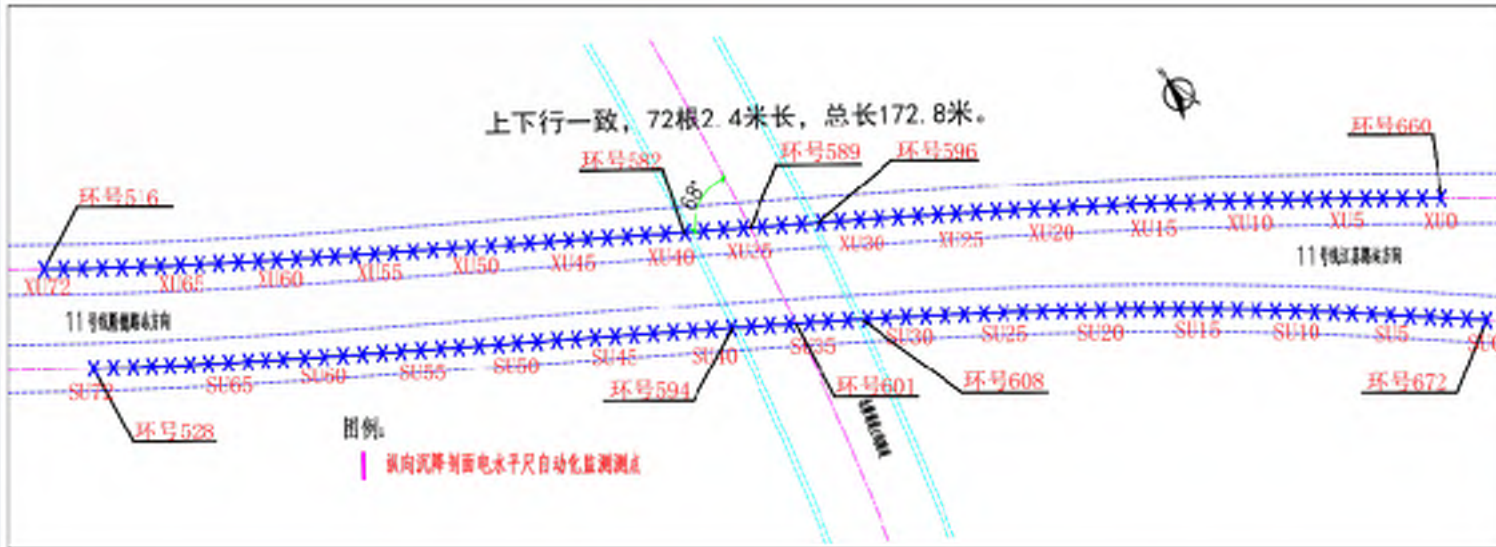
Automatic monitoring include EL beam and laser convergence survey were used. Monitoring zone on the existing Metro Line 11 Tunnel is 80m from both sides of the Beiheng Tunnel centreline and cover a total length of 172m.
